2018 3rd International Conference on Design, Materials and Manufacturing (ICDMM 2018) University of the Ryukyus

Some Thoughts on The Risk of Natural Disasters in Ryukyu Archipelago

Ömer AYDAN

University of the Ryukyus, Dept. of Civil Engineering, Disaster Prevention Research Center for Islands Regions

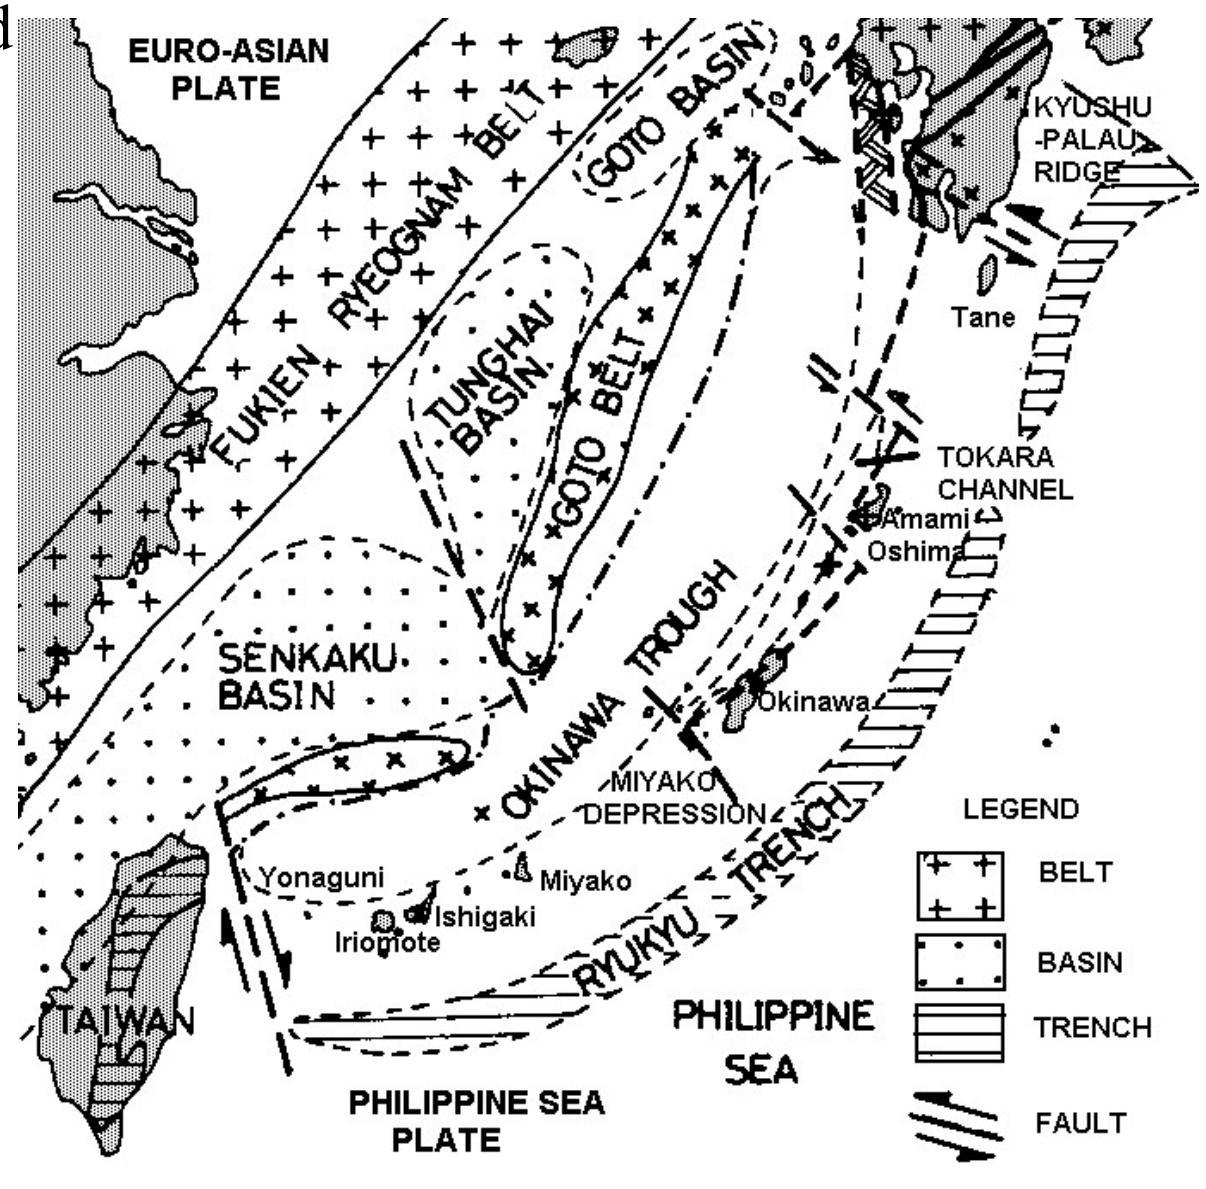
TECTONICS

Ryukyu arc is considered to be a convergent plate margin where the Philippine Sea plate is subducting beneath the Eurasian plate

The arc is a rifting fragment of continental crust and it is oriented NE-SW direction and the convergence rate between the Philippine sea plate and the Eurasia plate varies from 5 to 7 cm/yr.

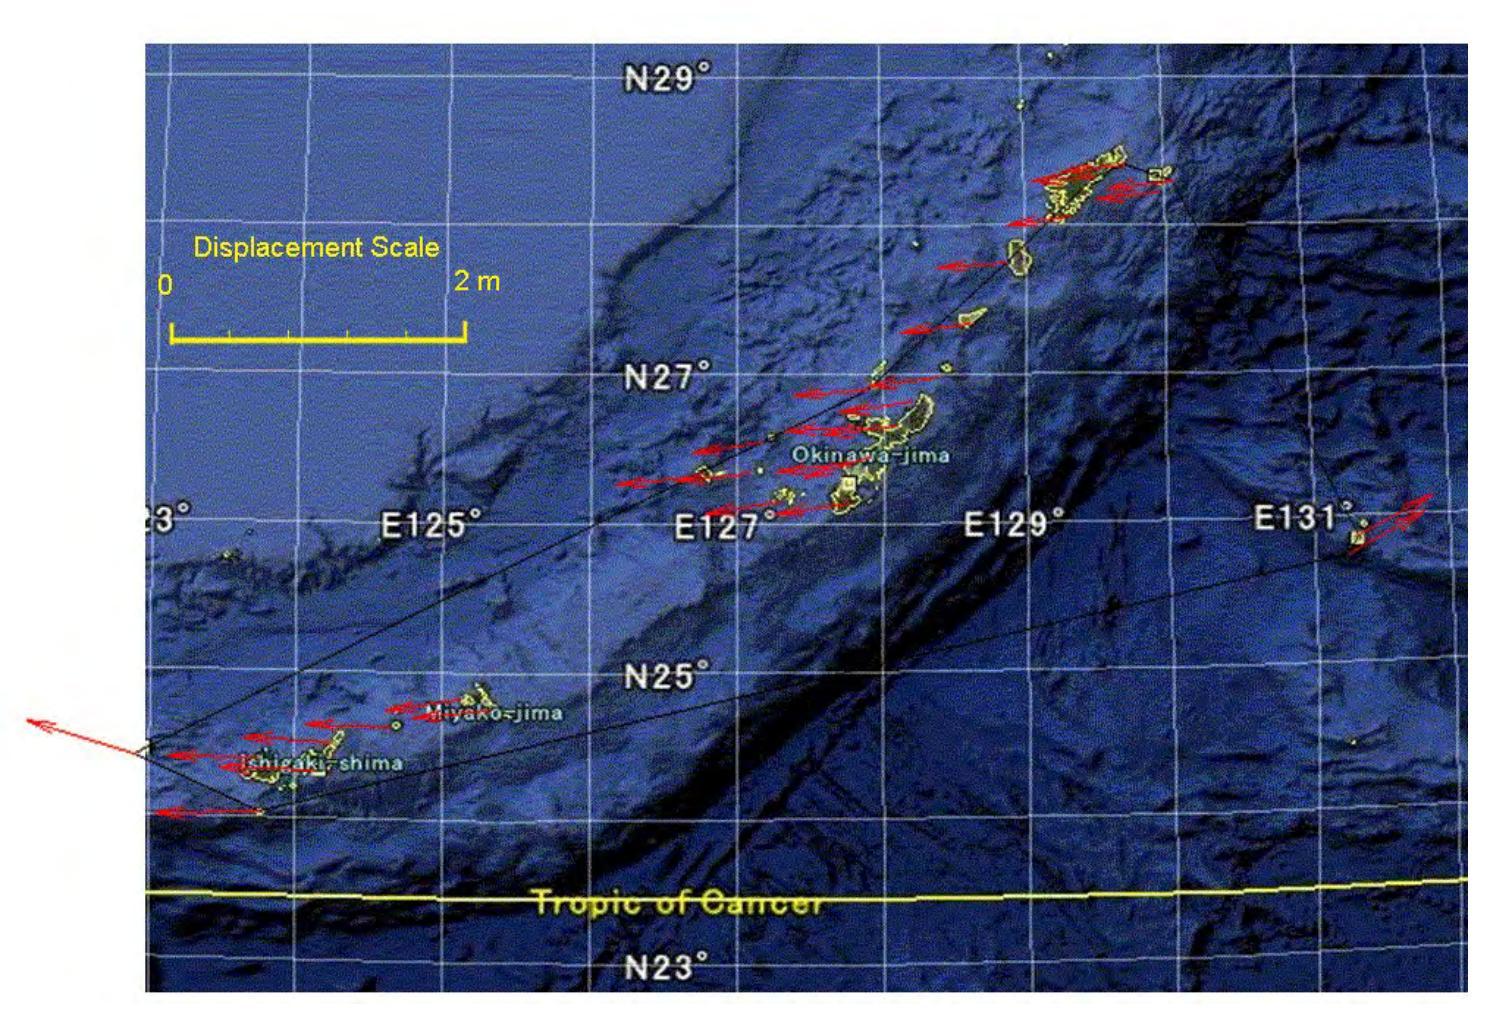
CRUSTAL DEFORMATIONS

In the region, the Philippine Sea plate moves towards WNW with respect to the interior of the Eurasia plate, having a relative velocity of approximately 60 mm/yr. This figure shows the crustal deformations measured from GPS network of GEONET of Japan

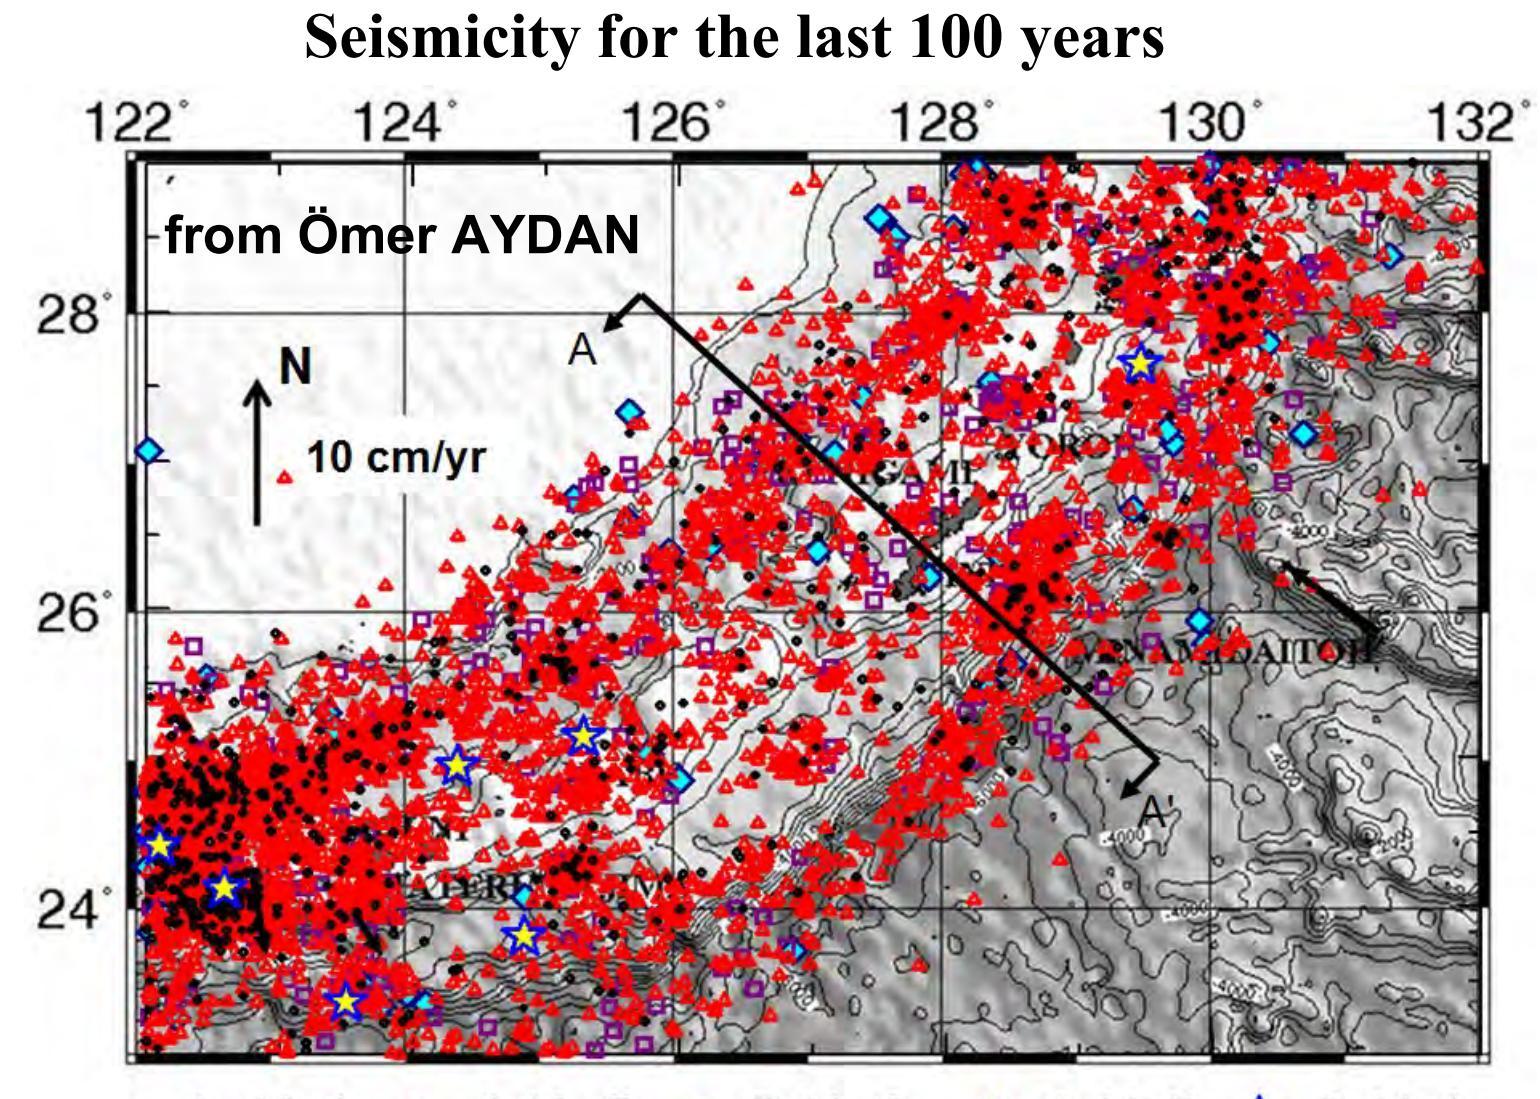
• $3 < M \le 4$ • $4 < M \le 5$ • $5 < M \le 6$ • $6 < M \le 7$ $1 < 7 < M \le 8$ The region is very seismically active and there are more than 5 large events having a magnitude greater than 7. It is not an aseismic region

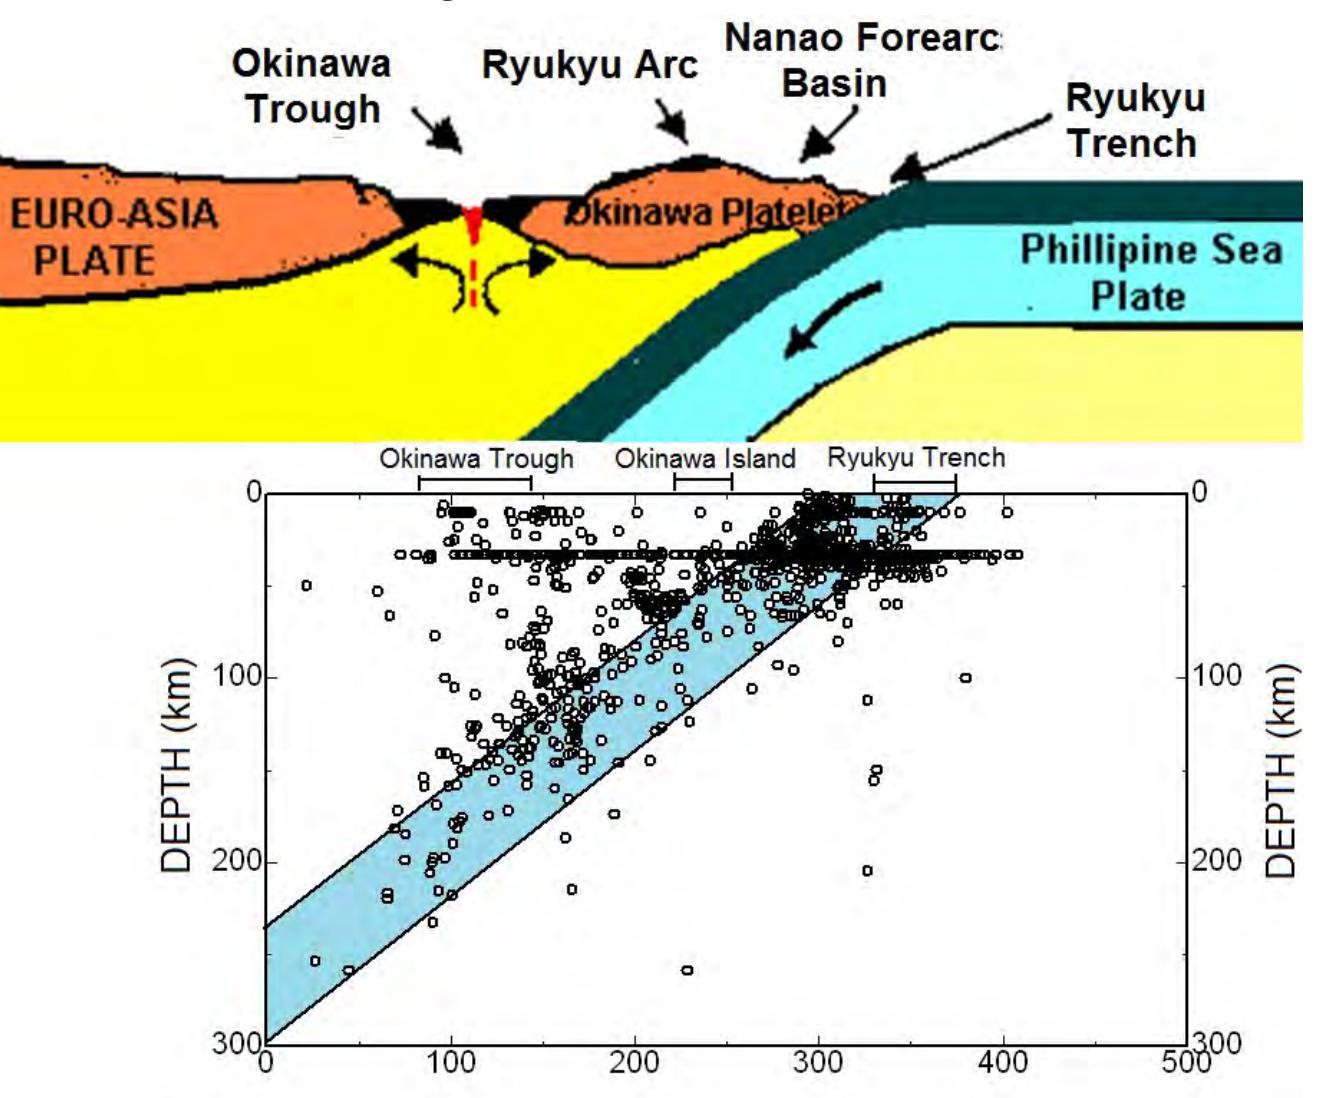
Seismicity on vertical cross section A-A'

As seen from the figure, the Philippine Sea plate subducts beneath the Okinawa plate-let with an inclination of about 30-35 degrees. On the west side, the seismic activity in Okinawa trough is also clearly seen.

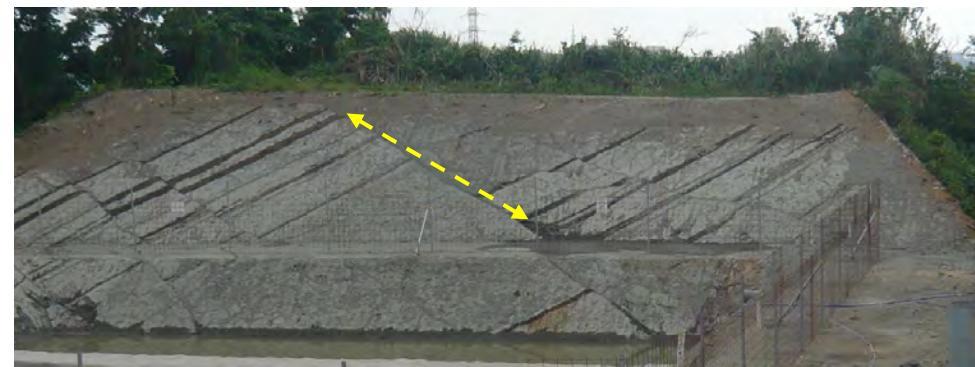
1) Minami-Uebaru Fault (Offset 10m)

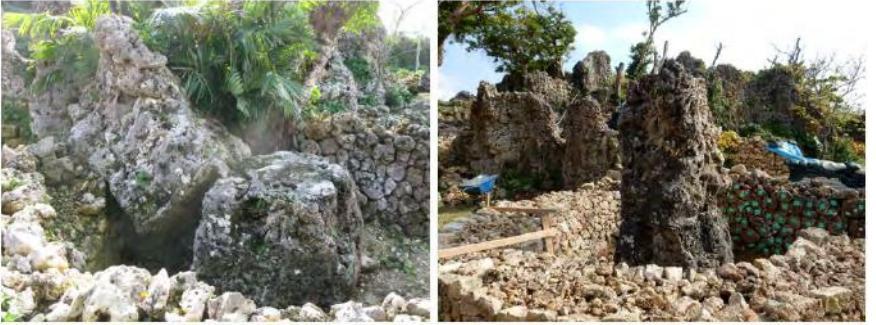
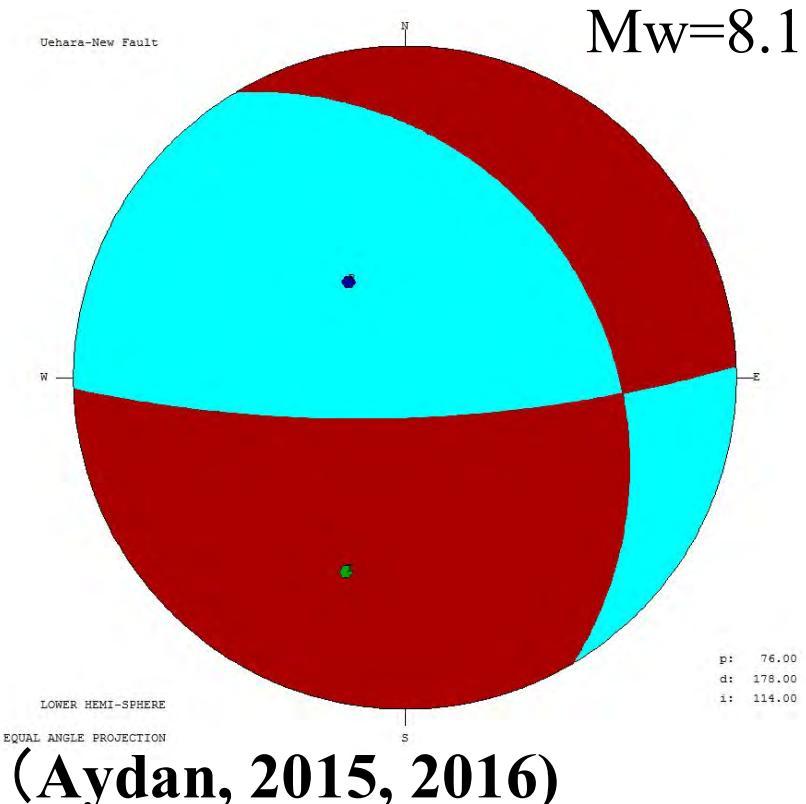
2) Toppled rock block in Nakagusuku Castle remains about 400 years ago

修復前 修復後 Estimated Maximum Acceleration > 0.7g

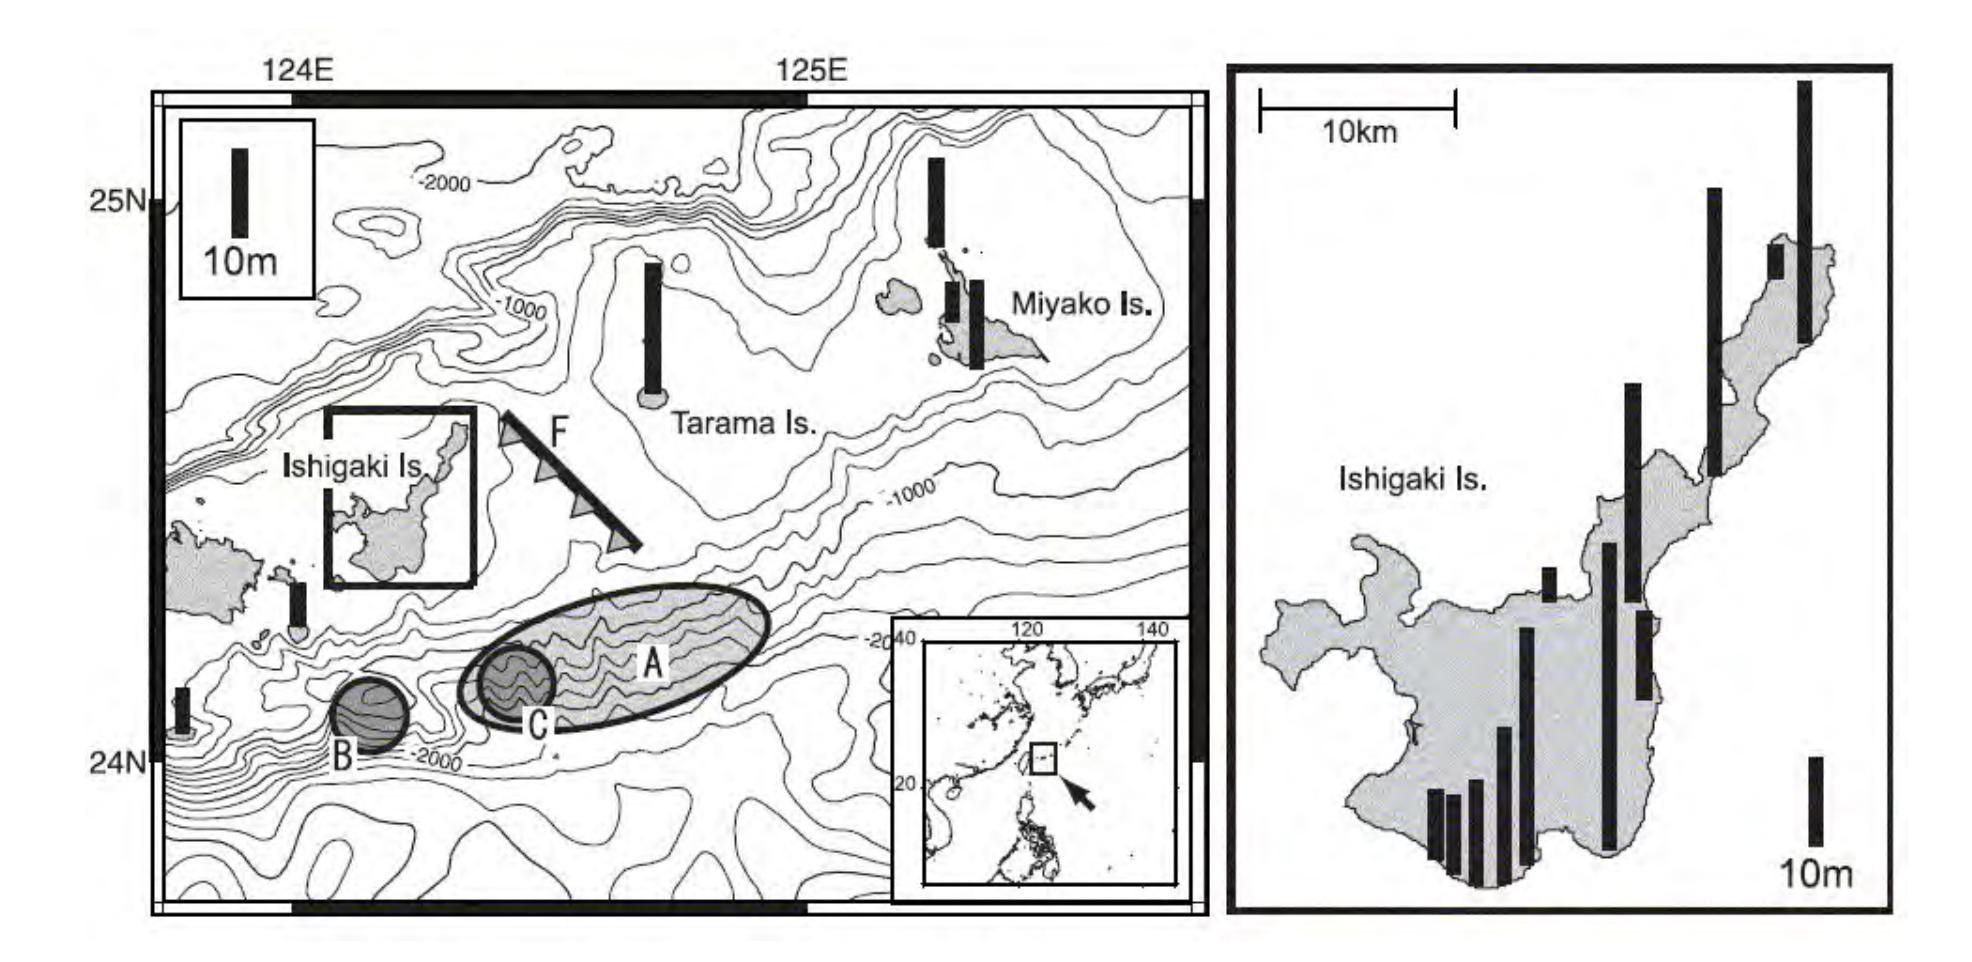
1771 Meiwa Earthquake

Tsunami run-up height in Ishigaki, Miyako and Tarama Island Values are incompatible with an earthquake of Magnitude 7.4

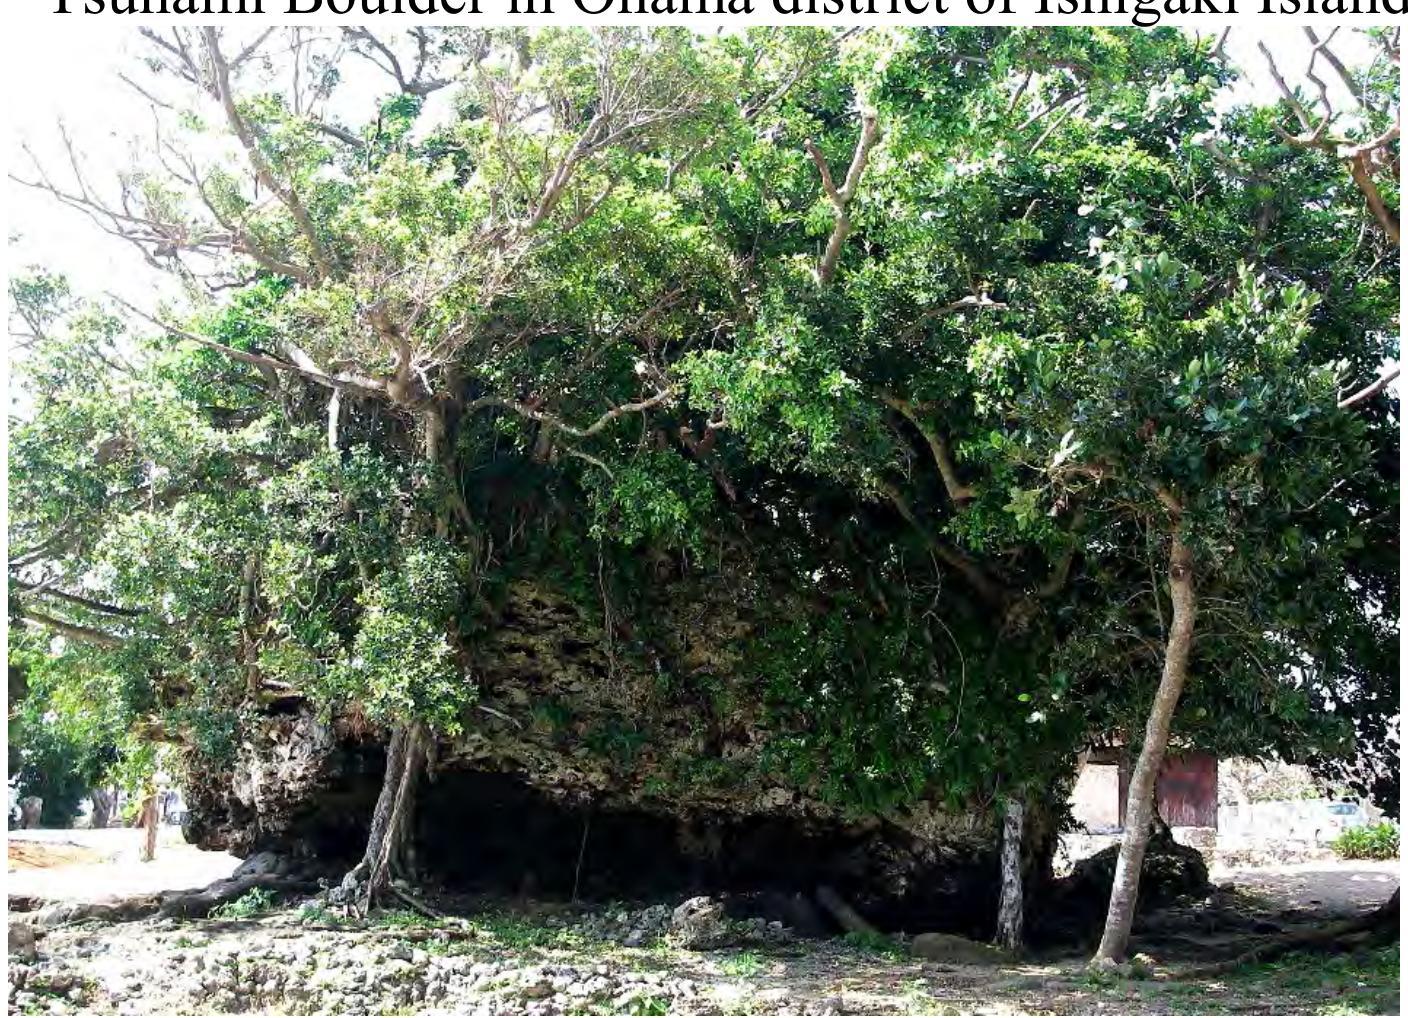
Tsunami Boulder in Ohama district of Ishigaki Island.

The ages of the coral fossils on some tsunami boulders in the vicinity of Ishigaki and were determined by Goto et al [14] and they identified several periods: about 200, 500, 1000, 2000, and 2500 years ago on the tsunami boulders.

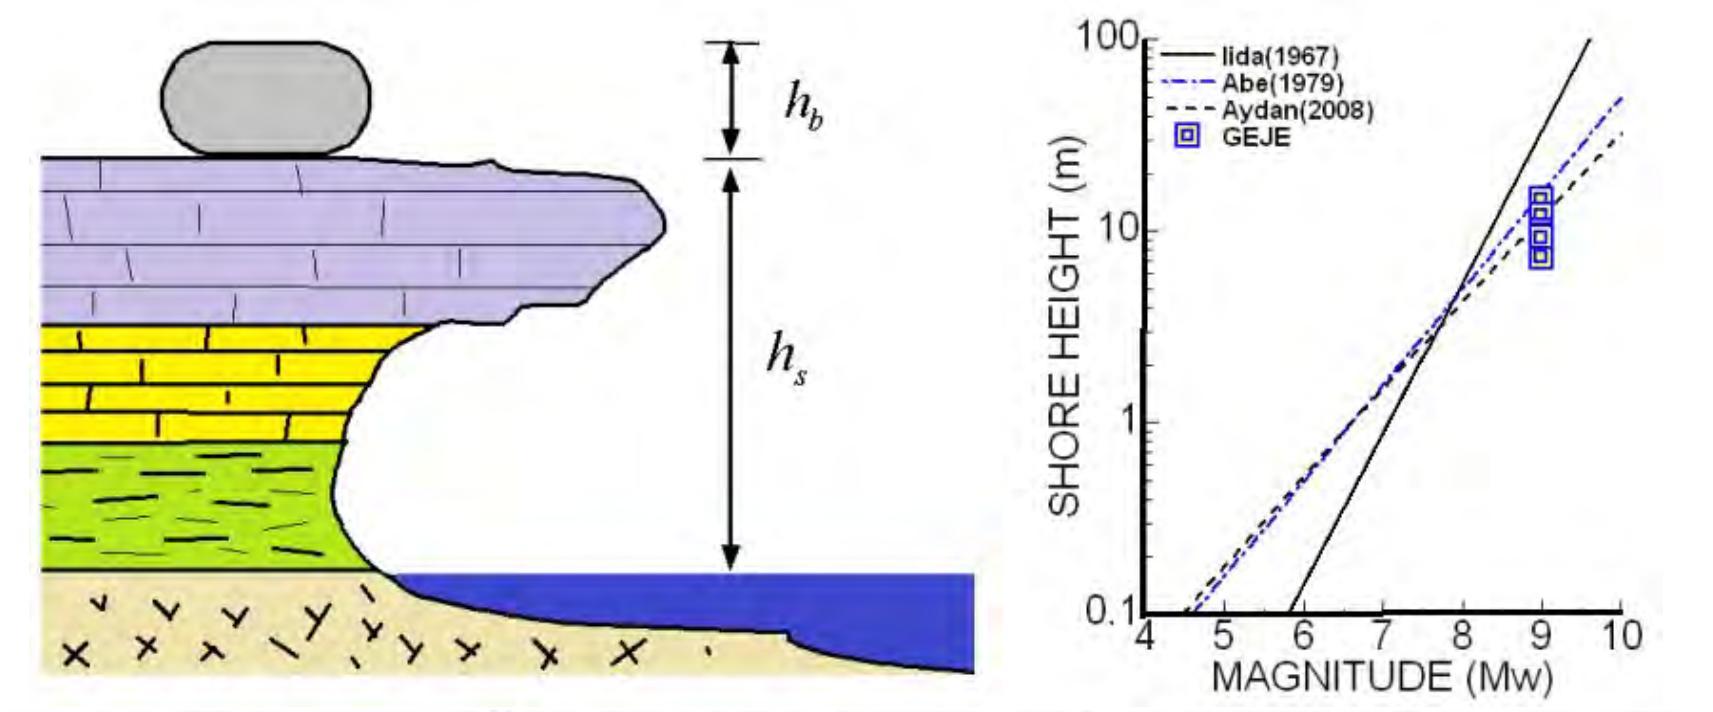
Estimation of Magnitude of Mega Earthquakes

Location	Mw (Lower Bound)	Mw (Upper Bound)
Miyako-Hennazaki	9.5	9.7
Shimoji	9.0	9.5
Okinawa-Kasakanca	9.0	9.2
Ishigaki-Ohama	8.6	9.1

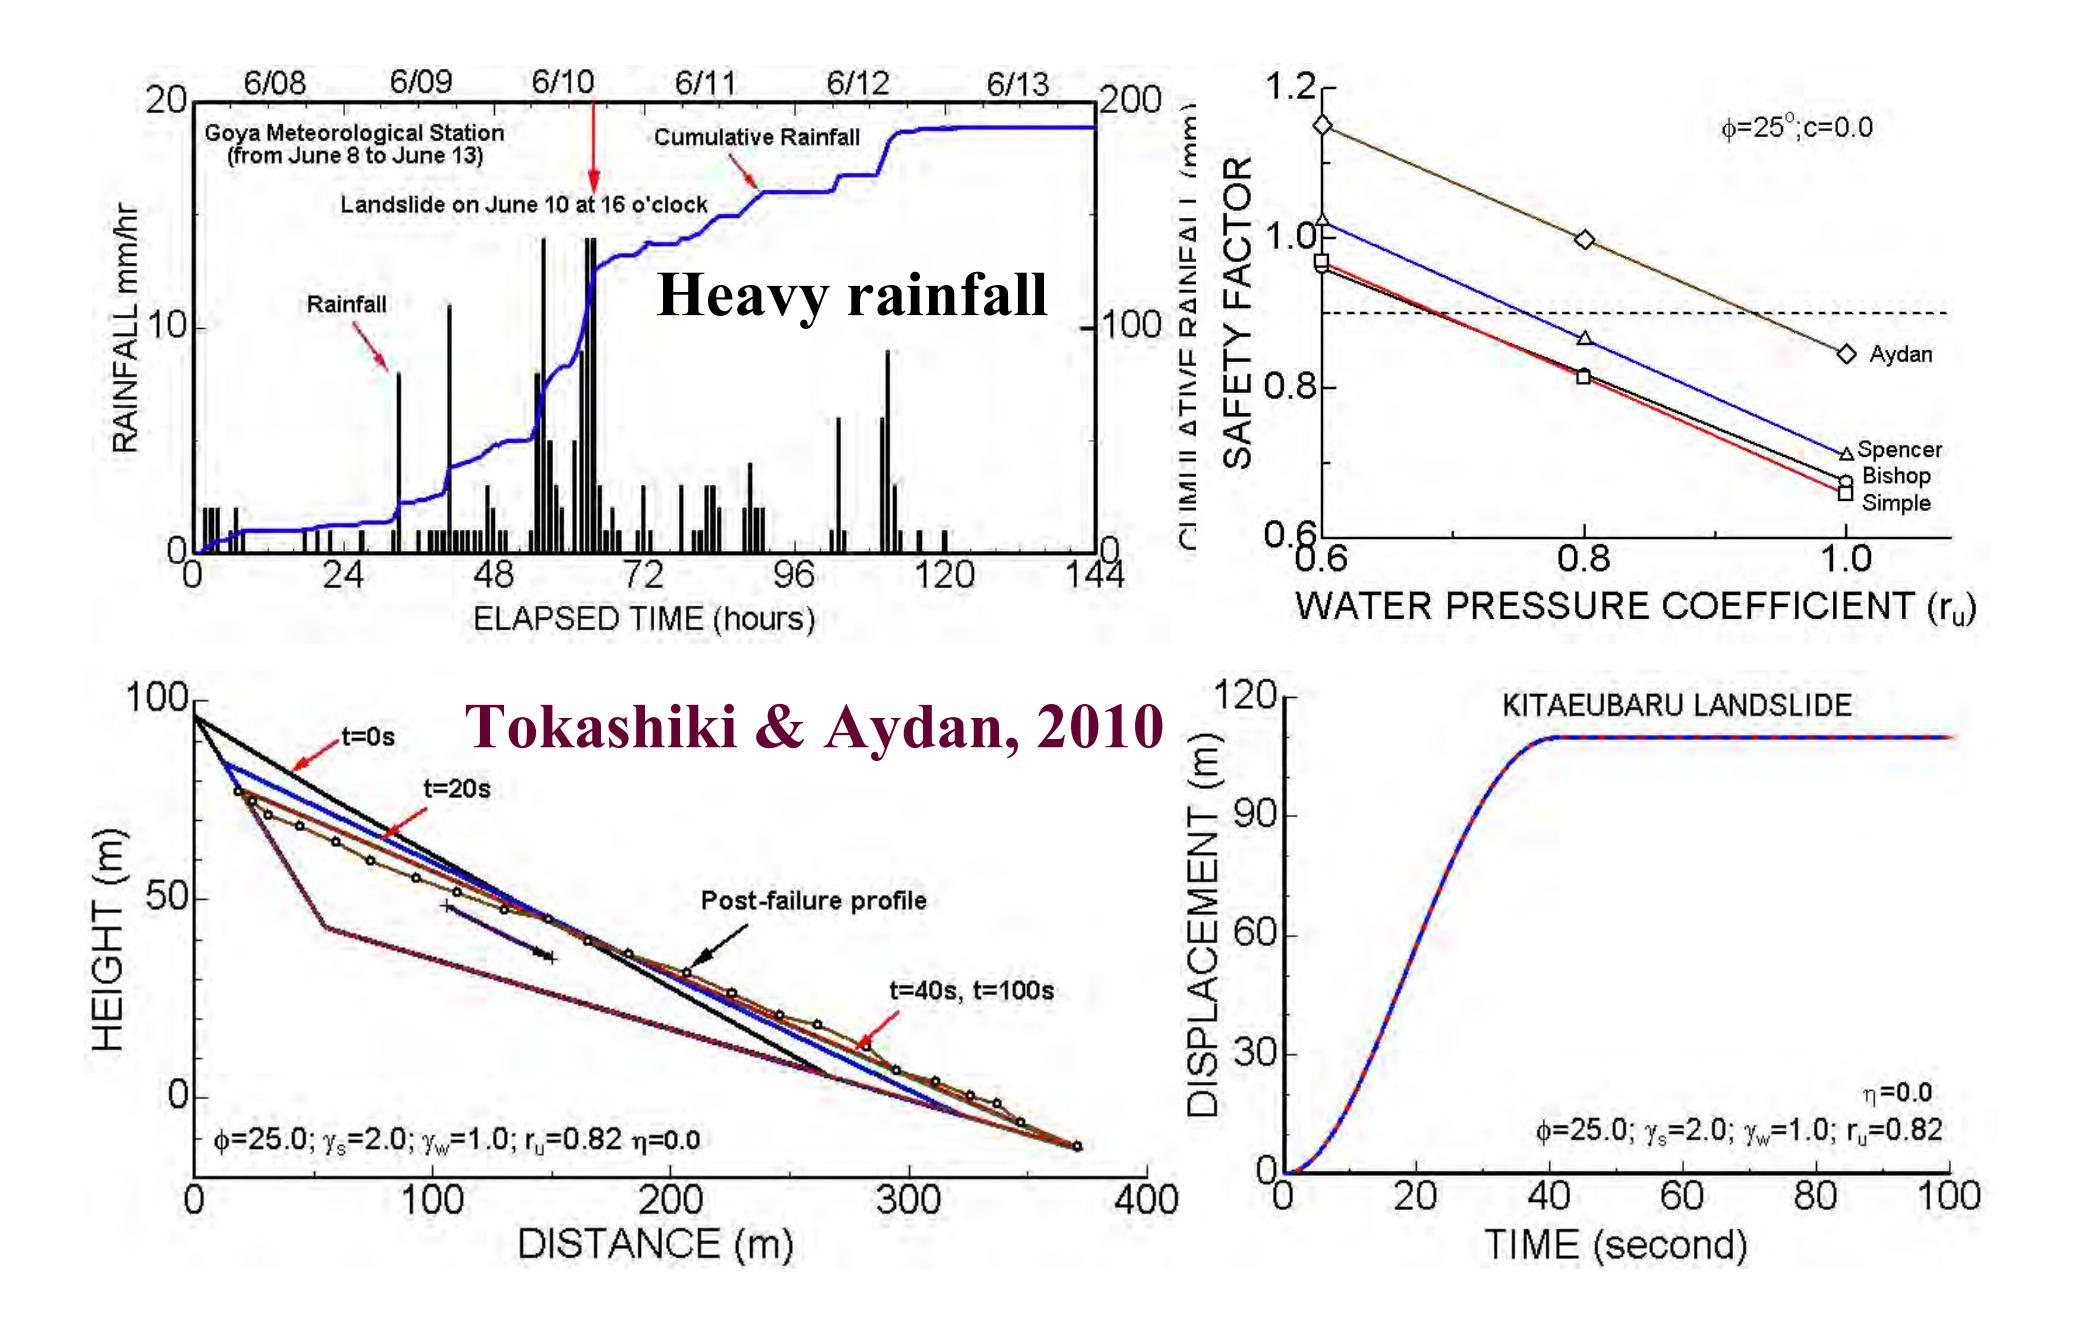
Evaluation of Causes of Kita-Uebaru Landslide & Debris Flow
